**PEACE RIVER REGIONAL DISTRICT**  
**REGIONAL PARKS COMMITTEE MEETING**  
**A G E N D A**

# PEACE VALLEY LOOKOUT

## Planning Feasibility Study

# STAGE 1 AND LIMITED STAGE 2 PRELIMINARY SITE INVESTIGATIONS: PEACE VALLEY LOOKOUT

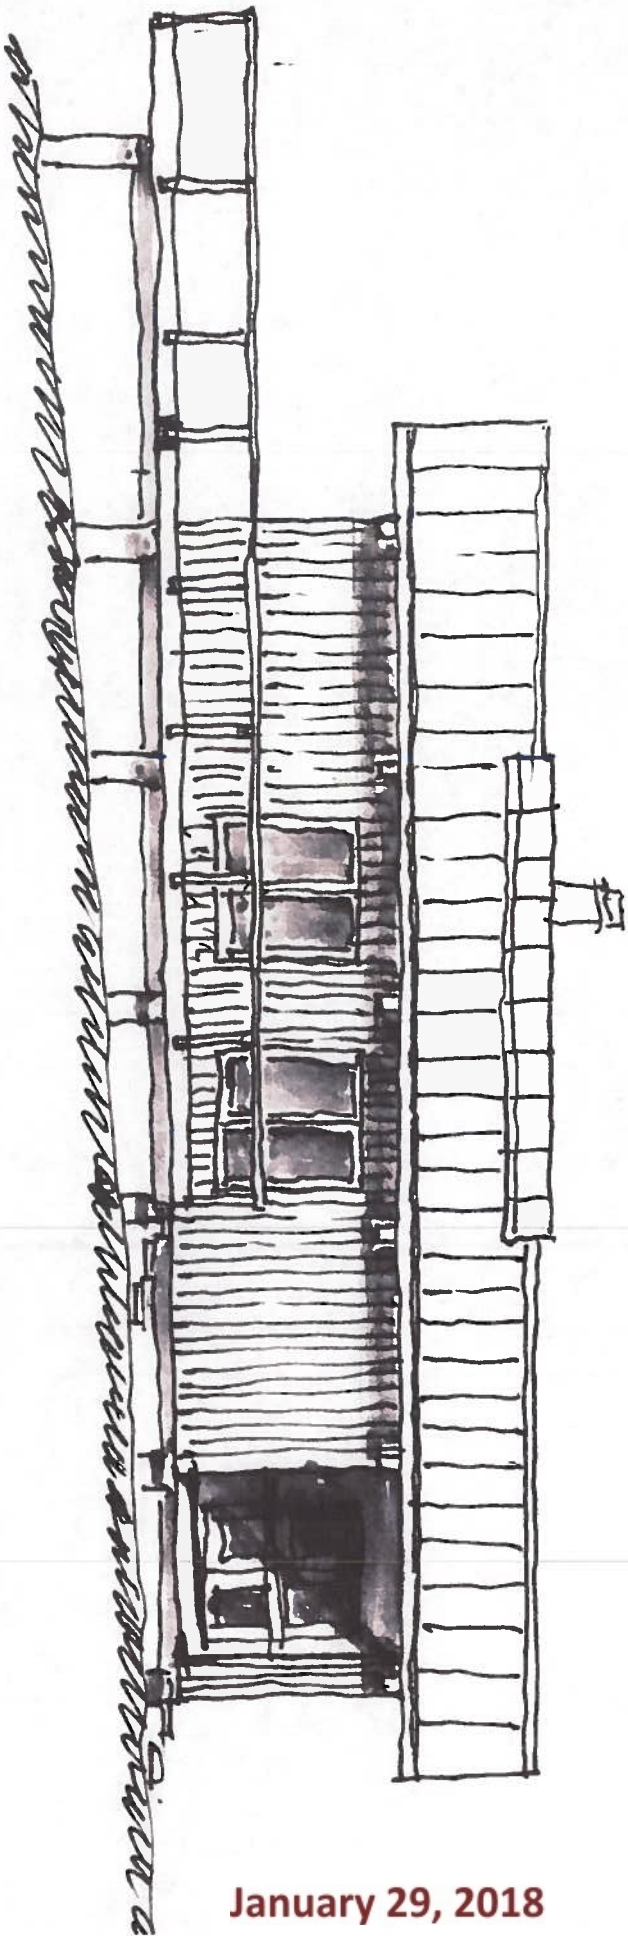
Sketches of Day Lodge that need to be developed into working plans.

East Elevation.

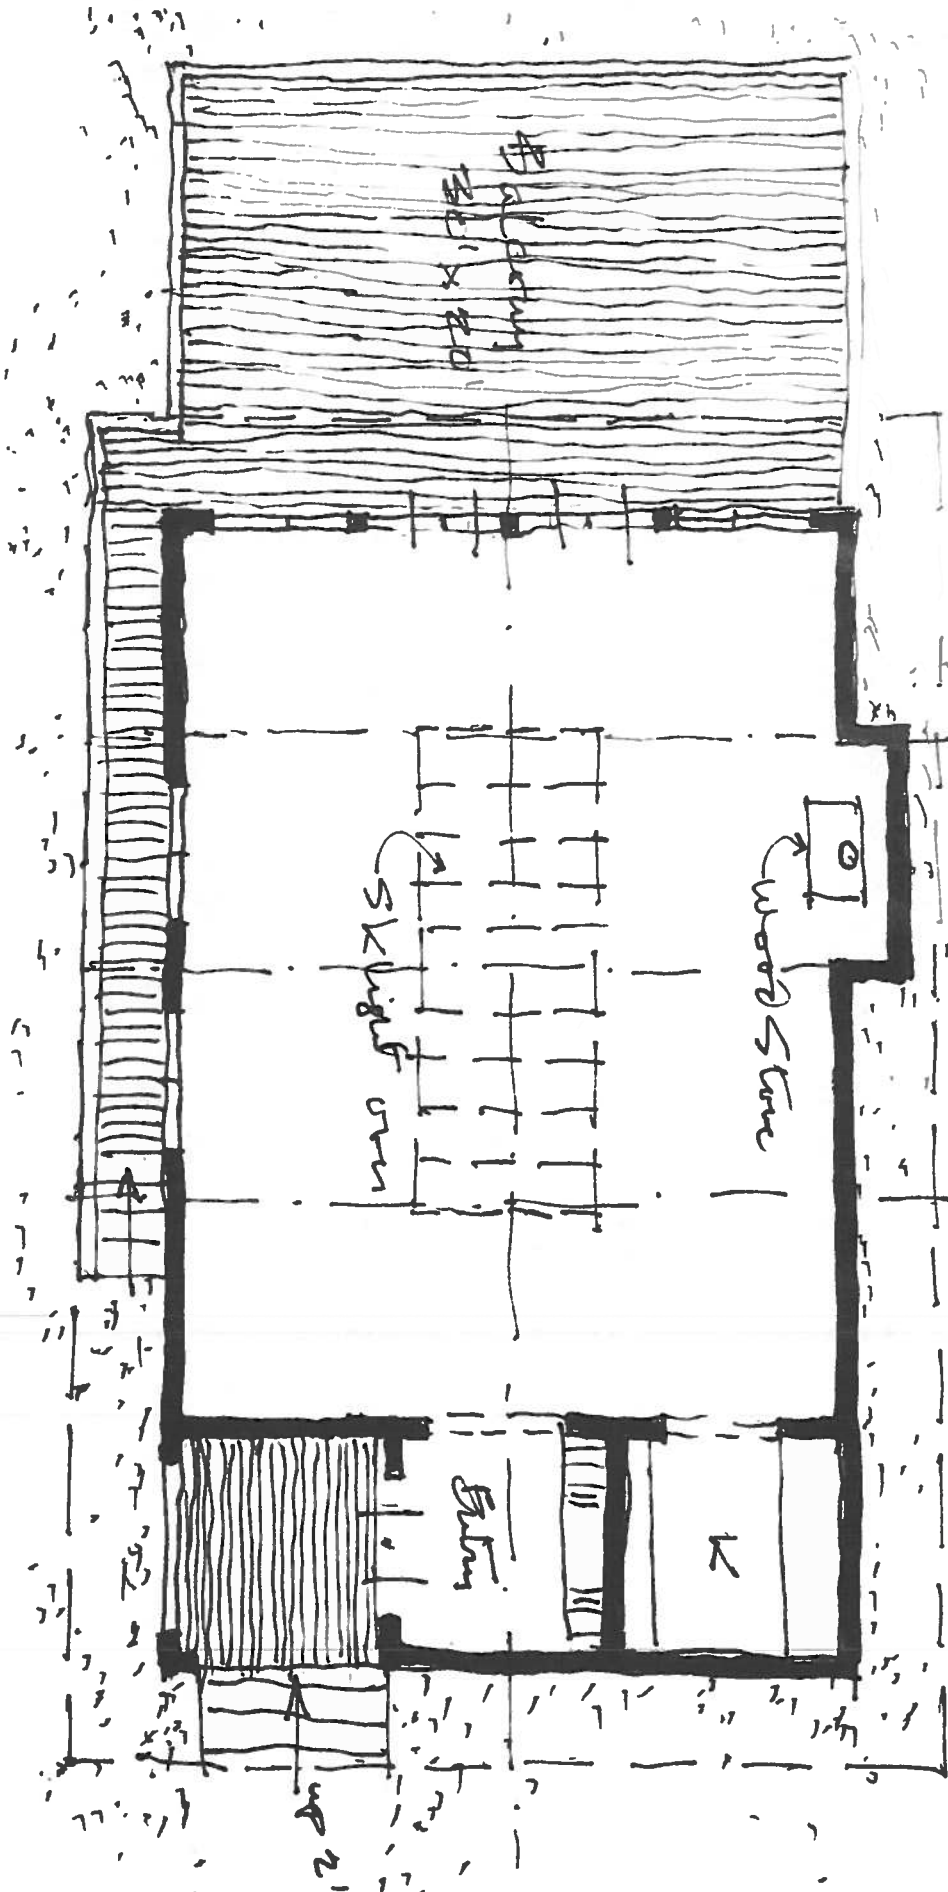
Plan.  
Scale: 1/8" = 10"

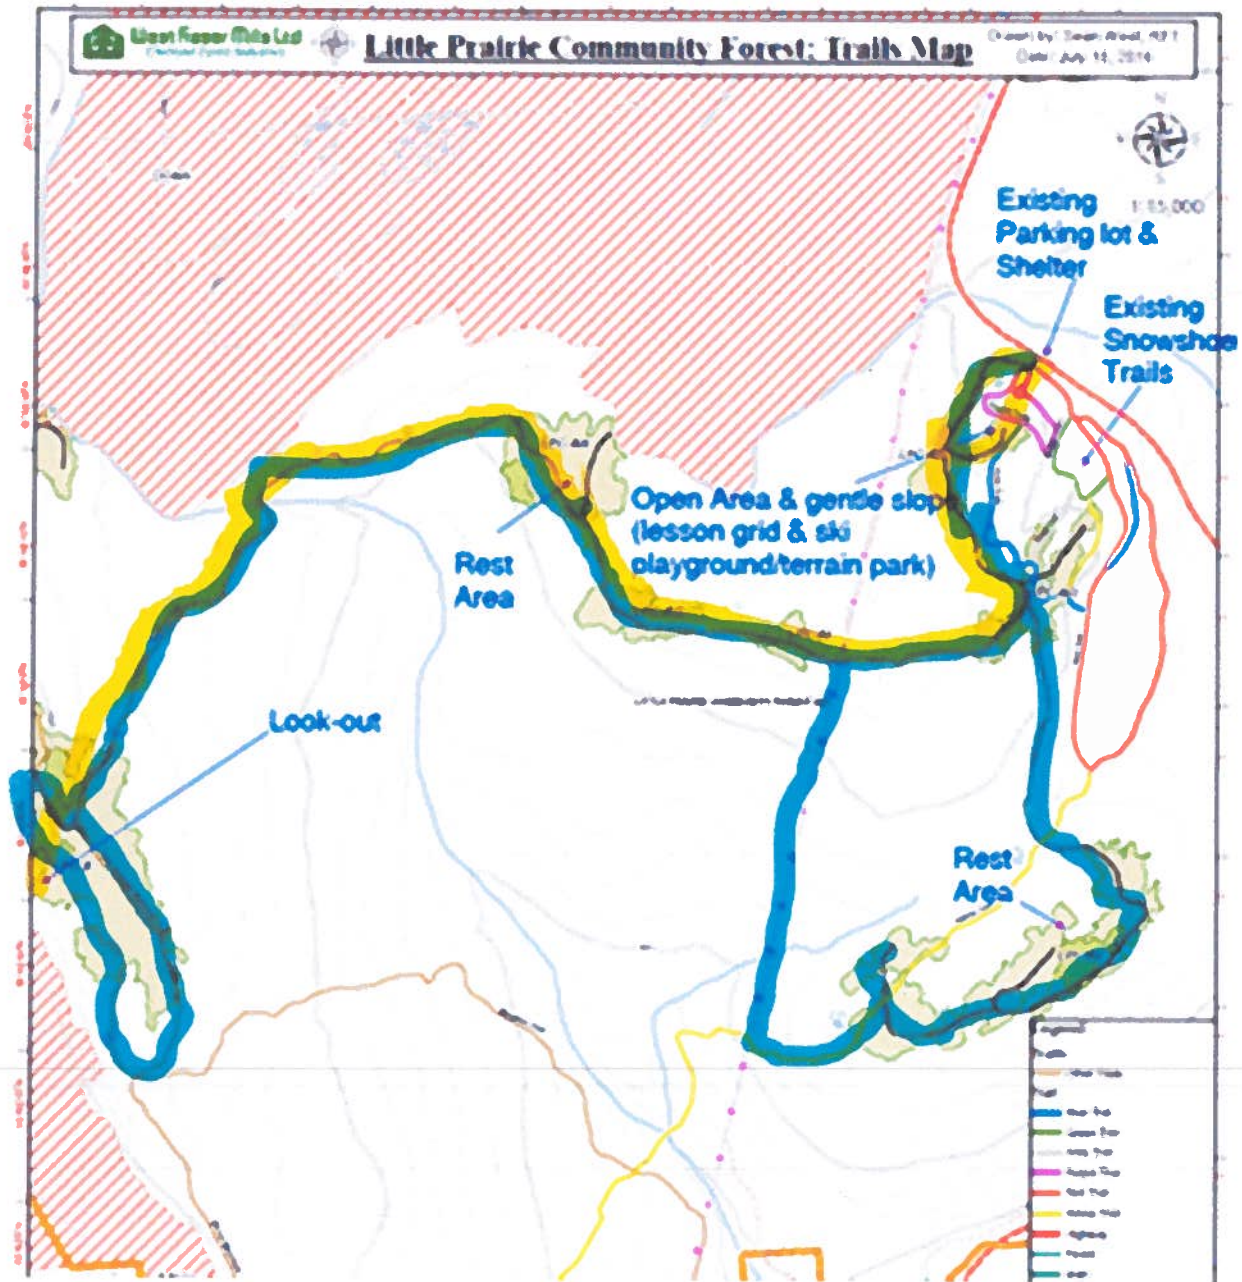
Yellow is the Caribou Trail for 2018-2019; Blue is to be expanded in the future

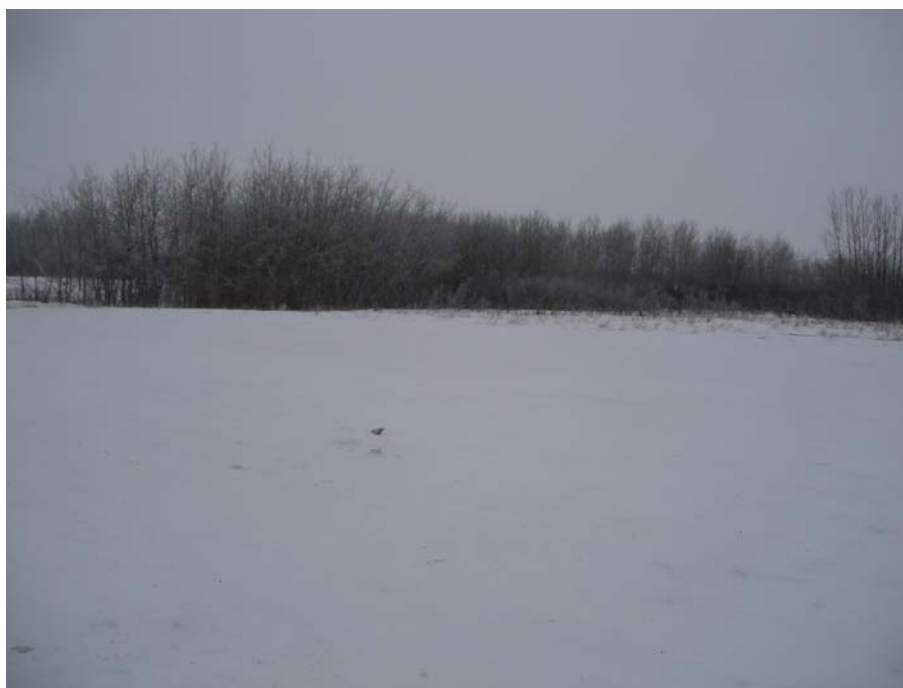
**Photo #1 – Looking north from the center of the Property.**

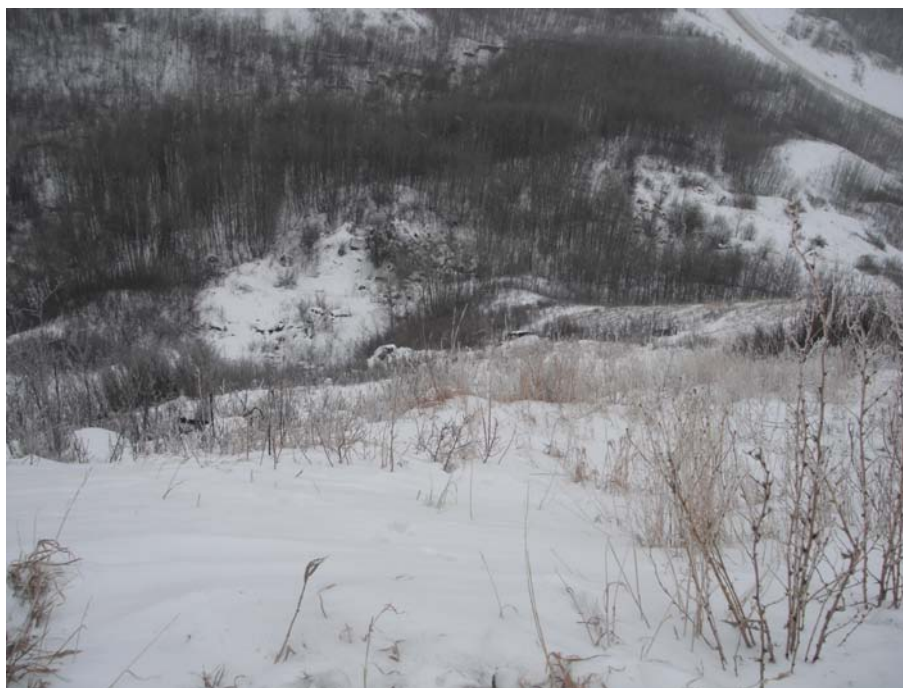
**Photo #2 – Bank on east side of the Property, looking towards the east.**

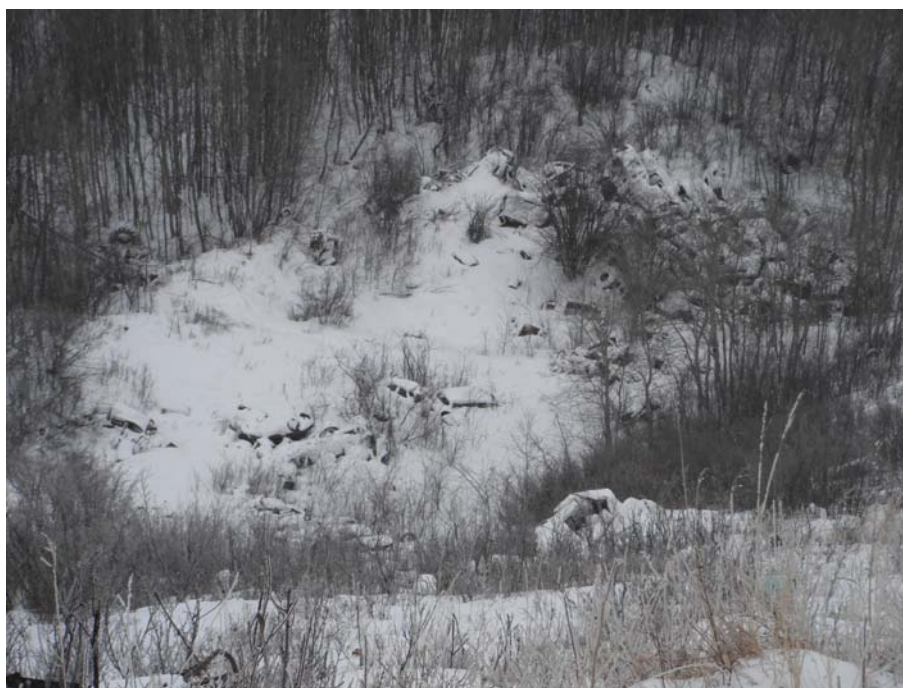
**Photo #5 – View of abandoned vehicles at the bottom of the bank on the east side of the Property (photo taken looking east).**

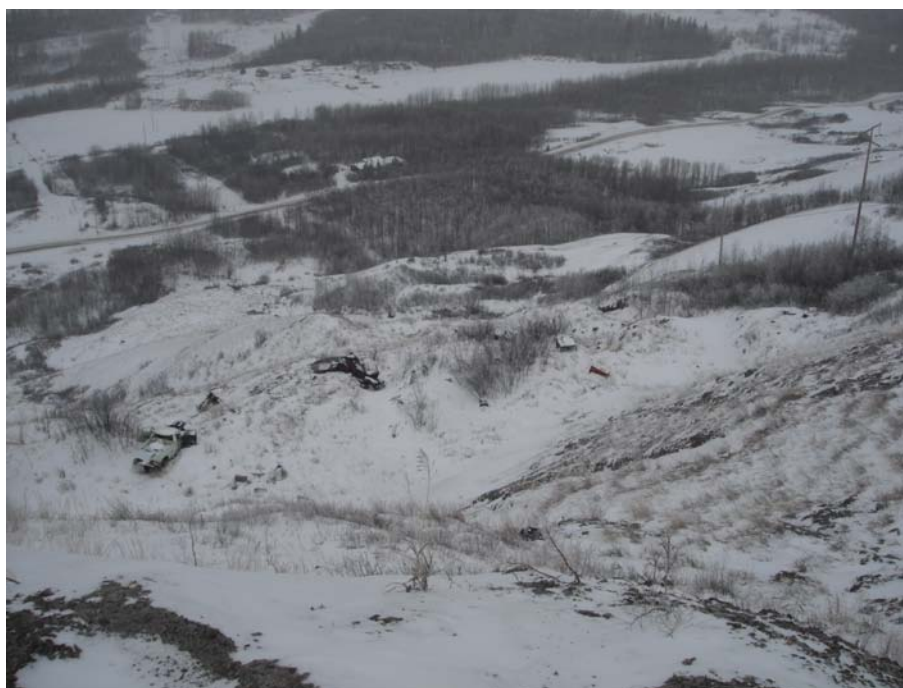
**Photo #7 – View of abandoned vehicles on the south edge of the Property (photo taken looking south). Concrete blocks in drainage ditch on northeast corner of the**

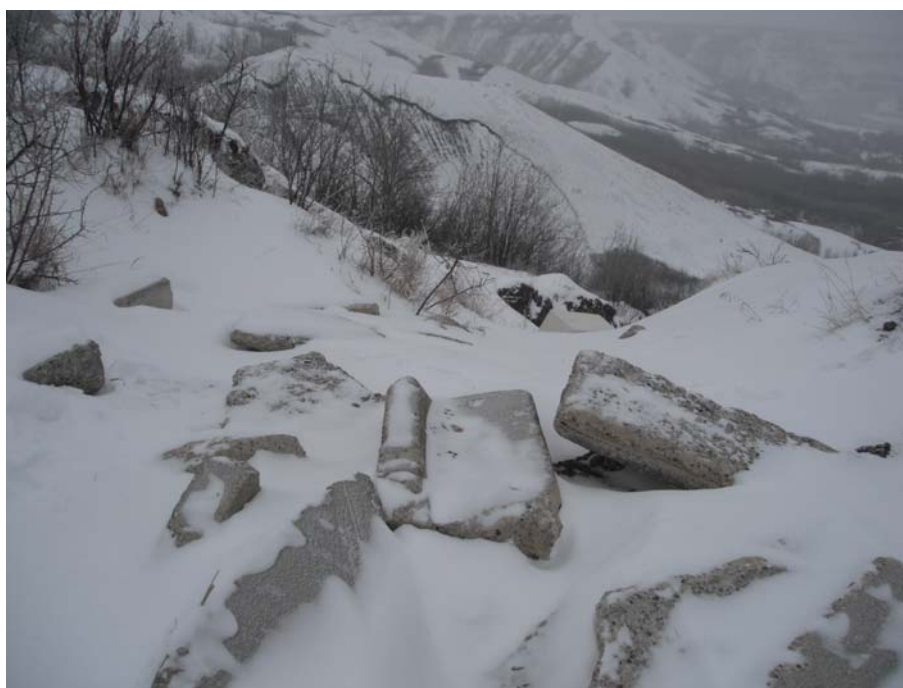
**Photo #8 – View of concrete blocks in drainage ditch on northeast corner of the Property (photo taken looking east).**

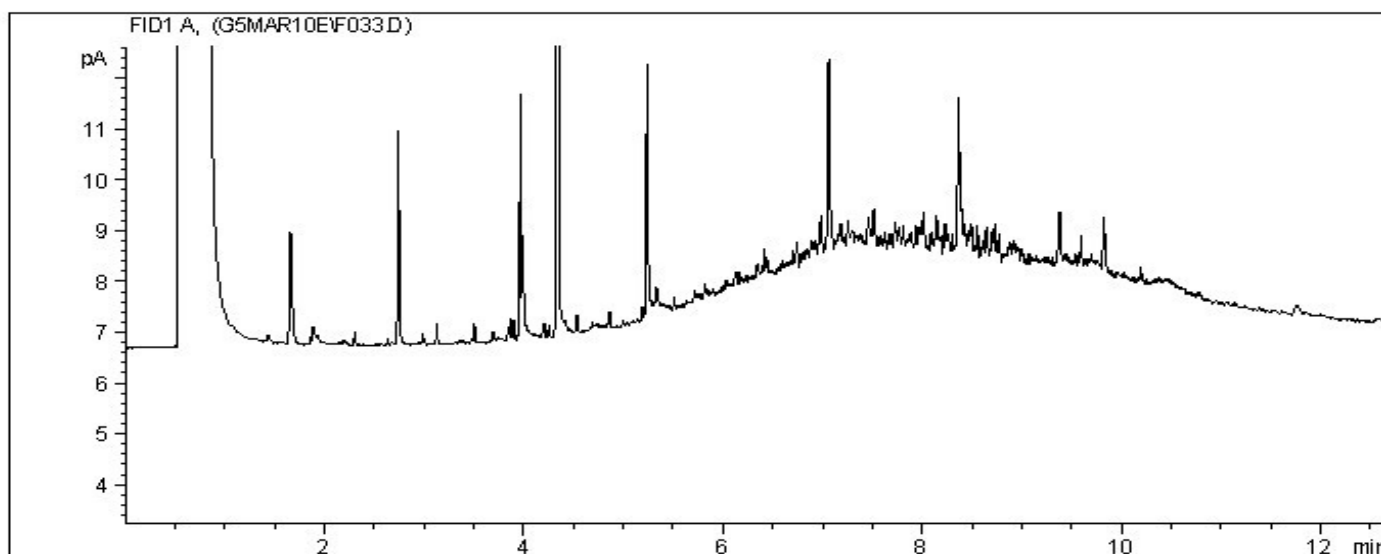
**BC Hydrocarbons in Soil by GC/FID Chromatogram**

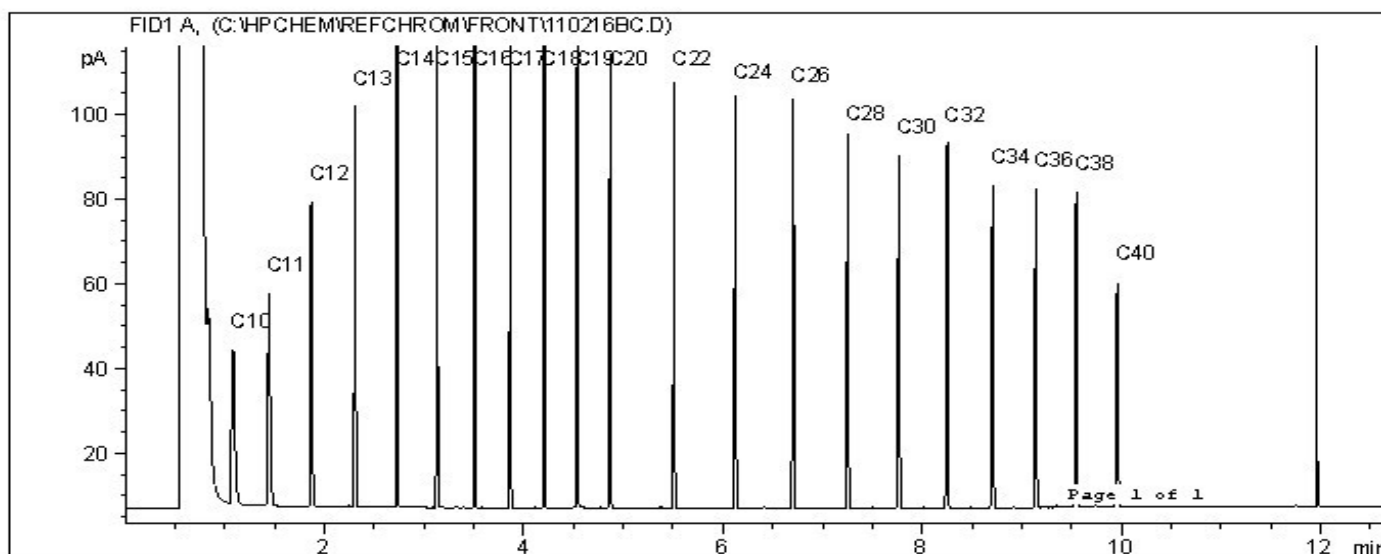
**Carbon Range Distribution - Reference Chromatogram**

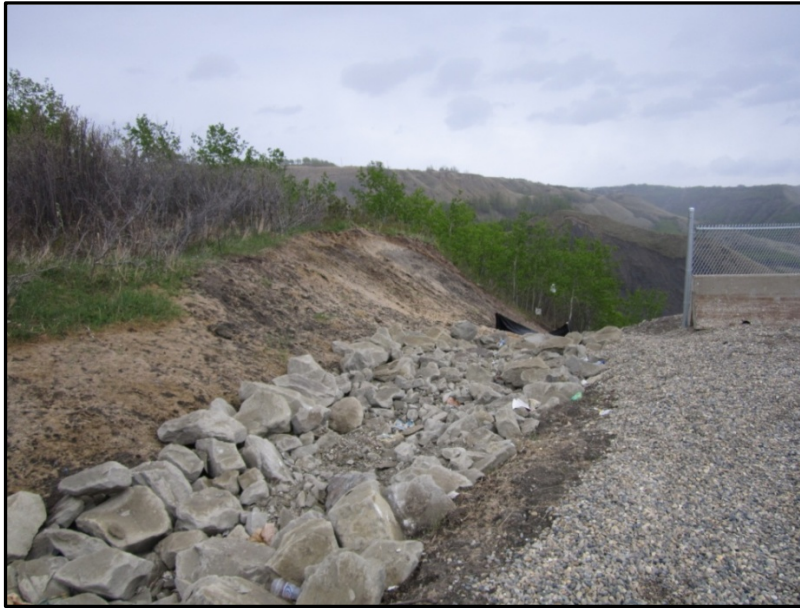
Slide 2.2b: Rip rap installed in the drainage ditch to the left of the viewing area
